Docket No. 217 – Development and Management Plan Inspection

Date: August 4, 2005

Location: Norwalk Substation Expansion

Location: Plumtree Substation Expansion , Bethel

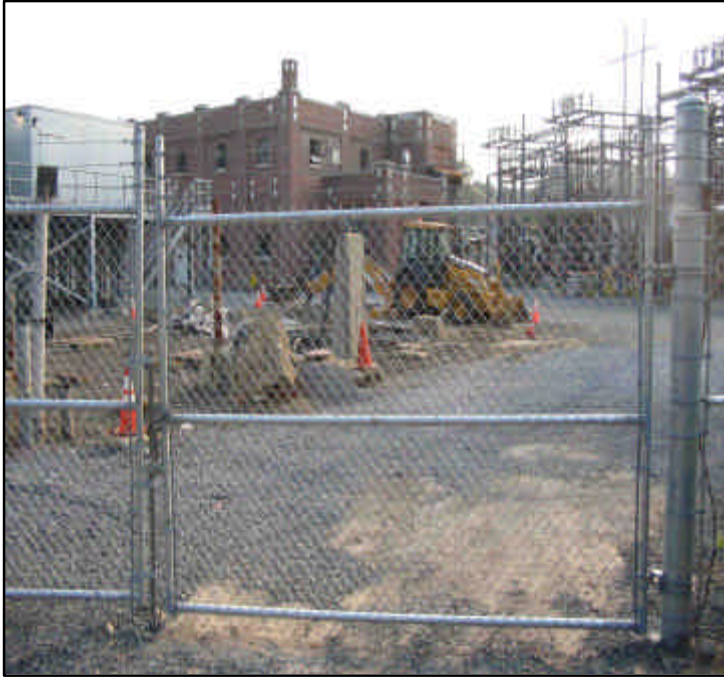
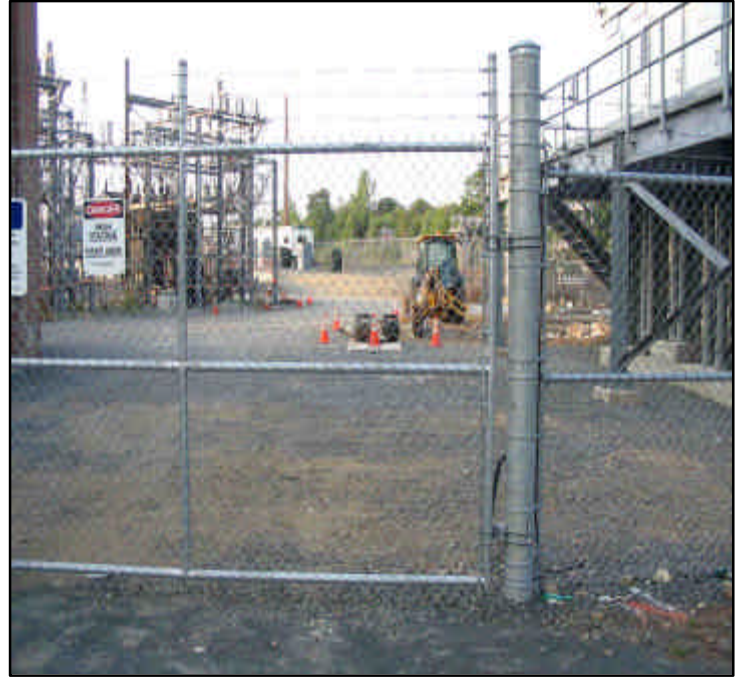
Norwalk Substation: Minor excavation and removal of old foundations continues within the live yard. (8/4/05)

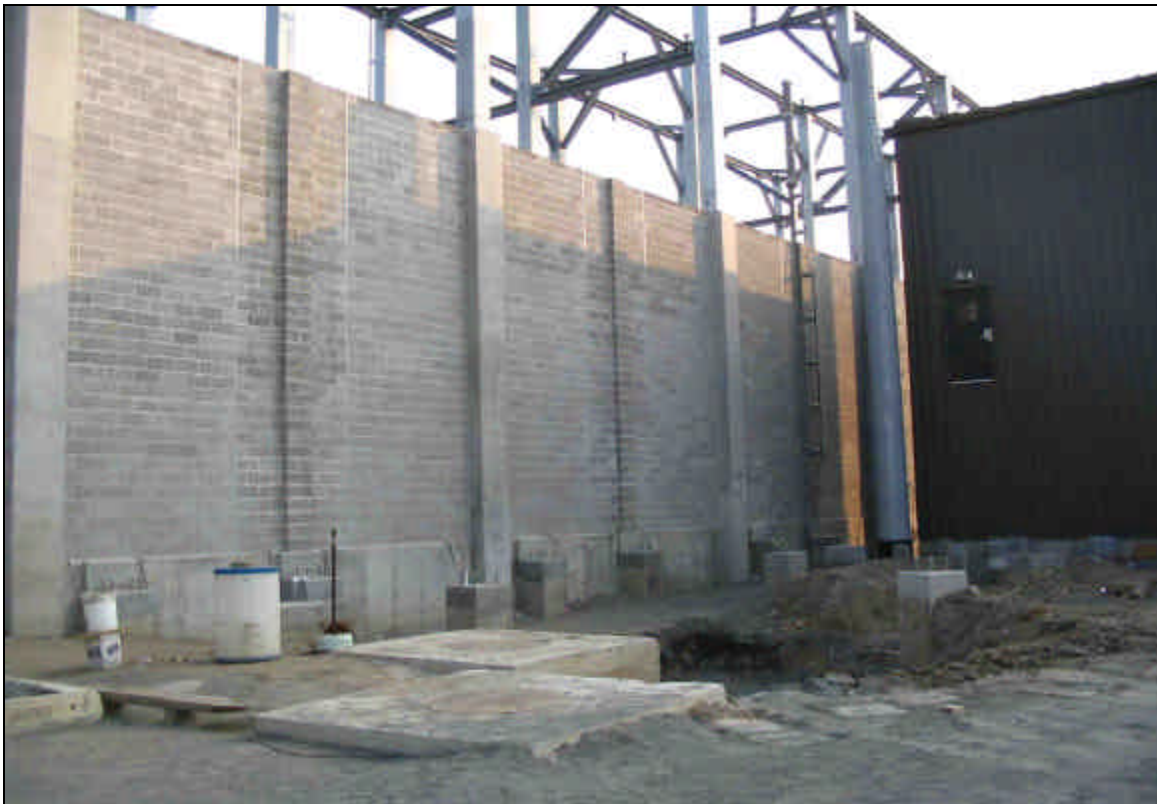
Minor excavation and backfill continues adjacent to the GIS building and masonry areas. (8/4/05)

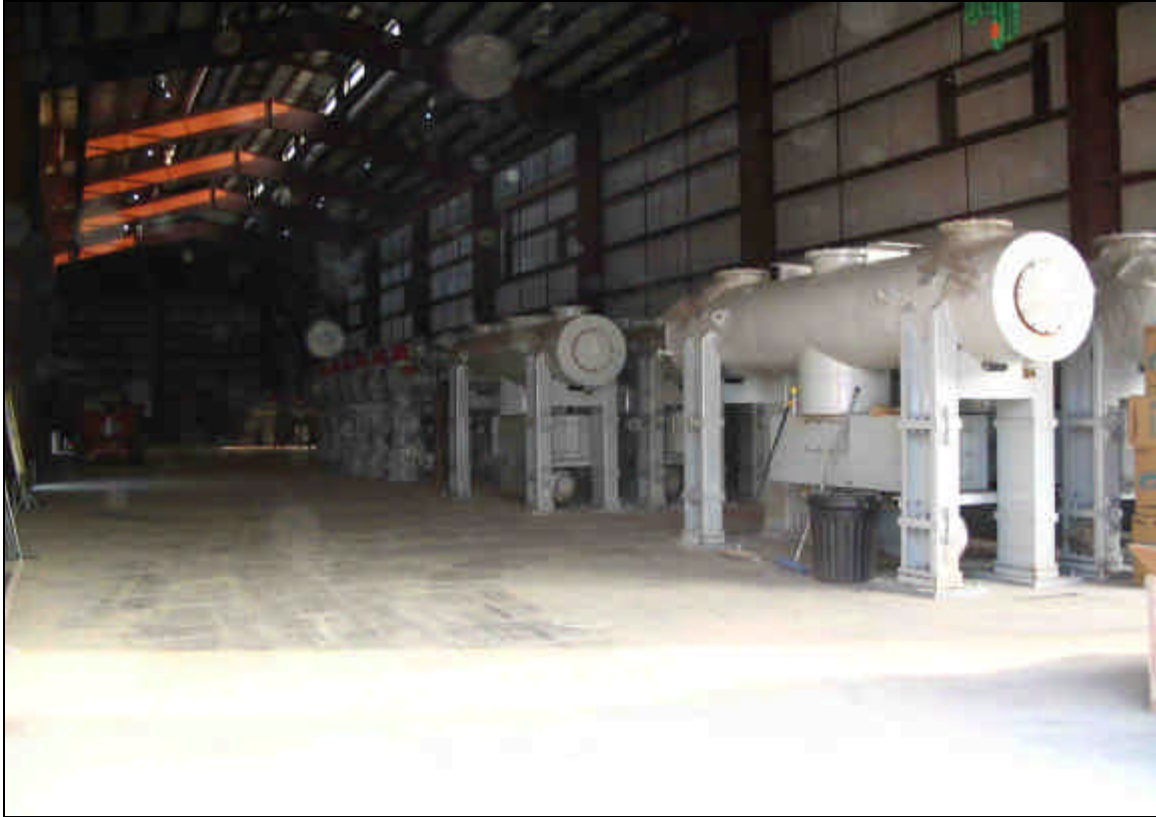
View into the GIS building where equipment is being installed. (8/4/05)

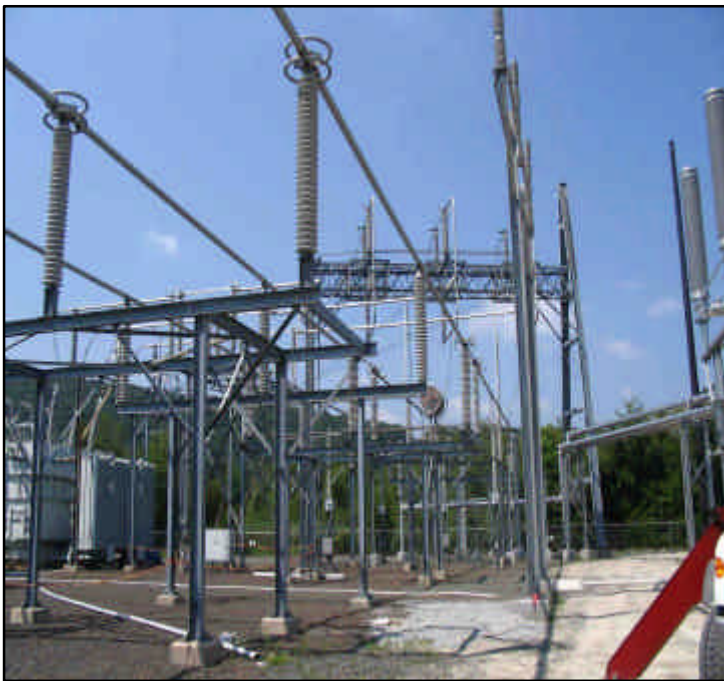
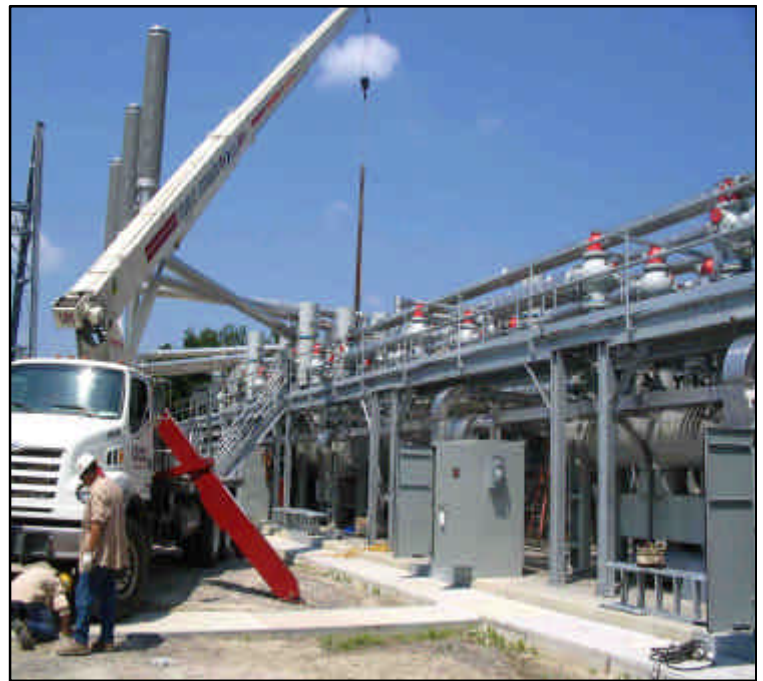
Plumtree Substation: Overall view of the structures in the yard. A crane was set up to remove access ladders within the equipment on the slab. (8/4/05)
